Metal-on-Metal Hips:

Device Mechanics and Failure Modes

Steven M. Kurtz, Ph.D.,
and Richard Underwood, Ph.D.

Exponent, Inc., and Drexel University

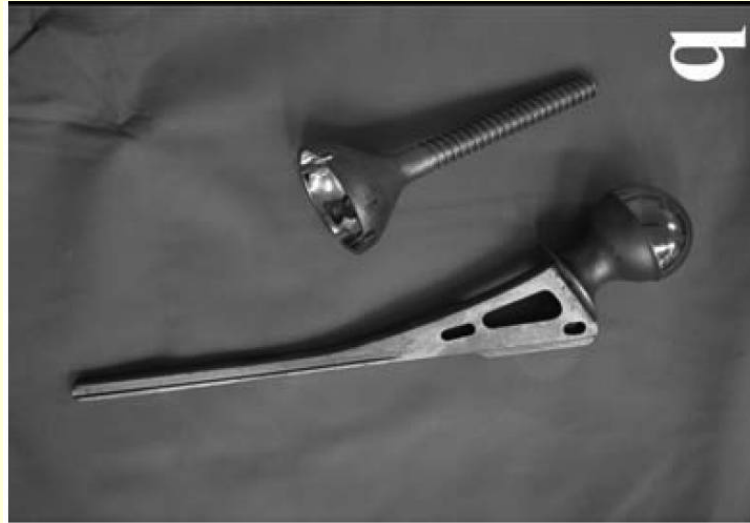
Ring Metal on Metal Total Hip Replacement

Explanted after 23.5 years

Femoral head Wear Rate $0.43 \mu\text{m}/\text{year}$

Acetabular cup wear Rate $0.35 \mu\text{m}/\text{year}$

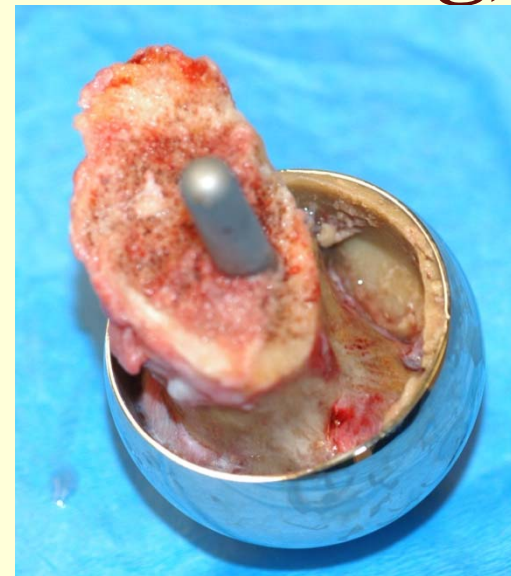
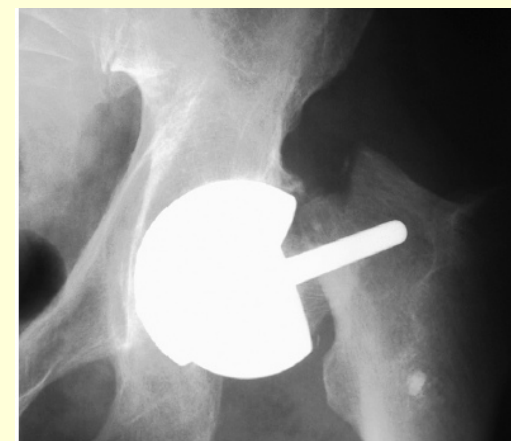
Femoral Complications (Resurfacing)

- Femoral neck thinning
- Femoral loosening
- Femoral neck fractures
- Learning curve
- Patient selection

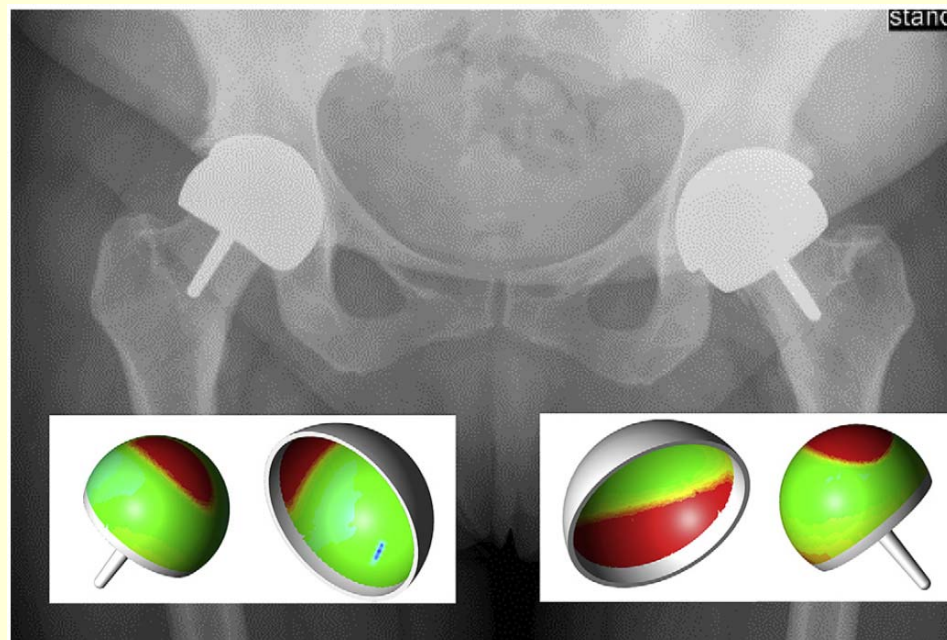
Elevated Wear (Resurfacing, THA)

Twin revisions after 19 and 58 months

Evidence of wear on all components

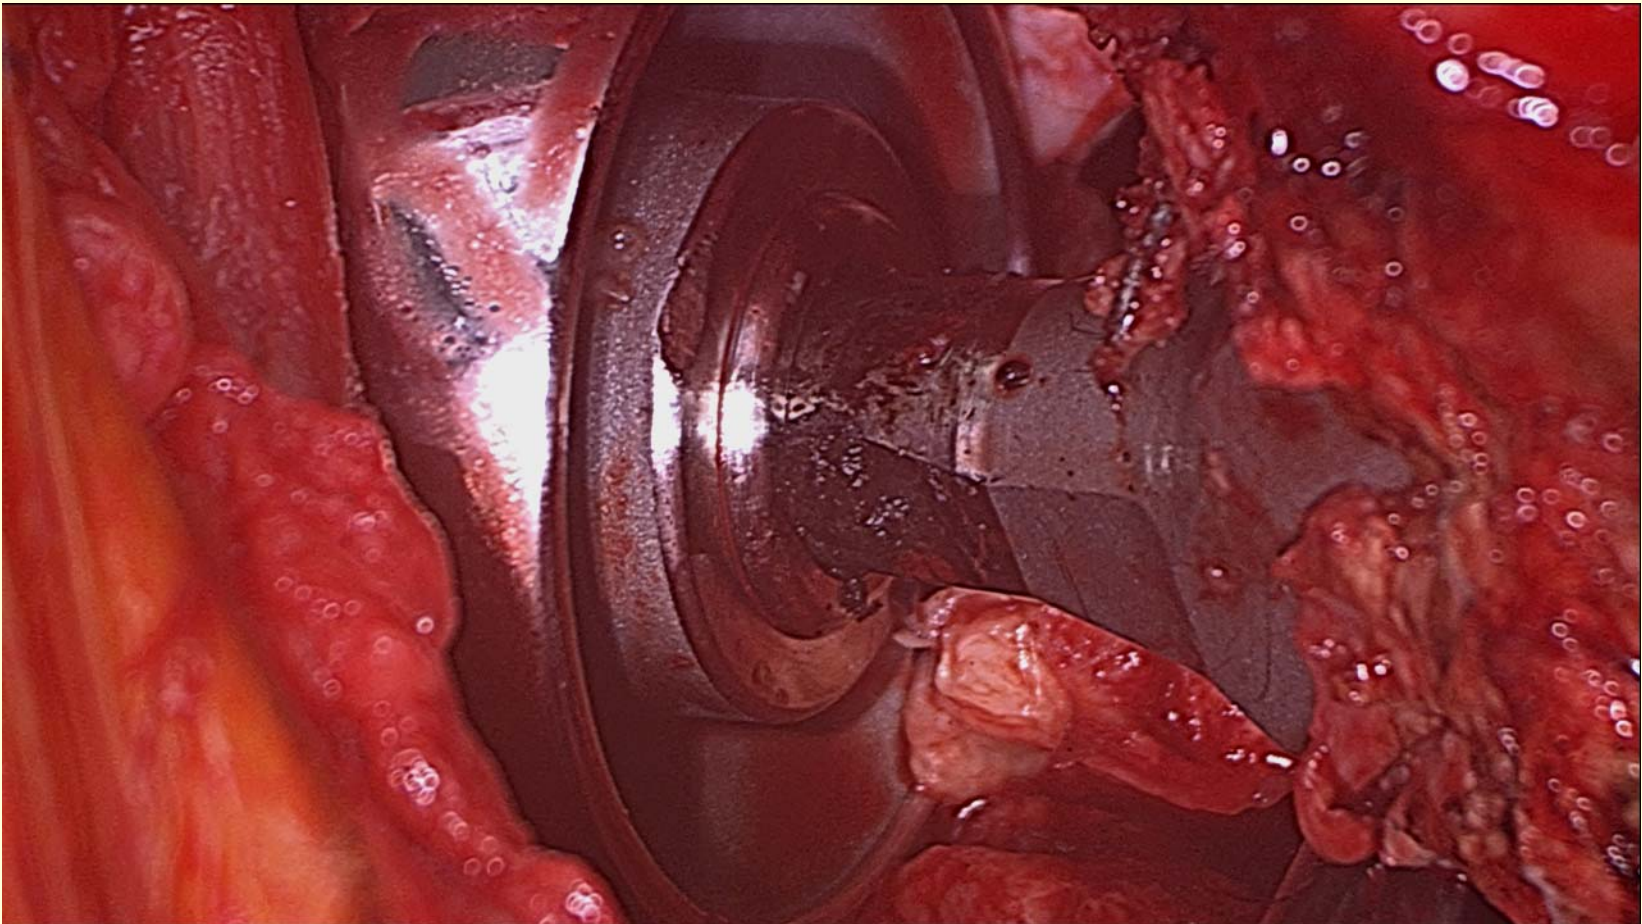
Taper Corrosion, “Trunnionosis” (THA)

Black deposits observed at taper interface during revision

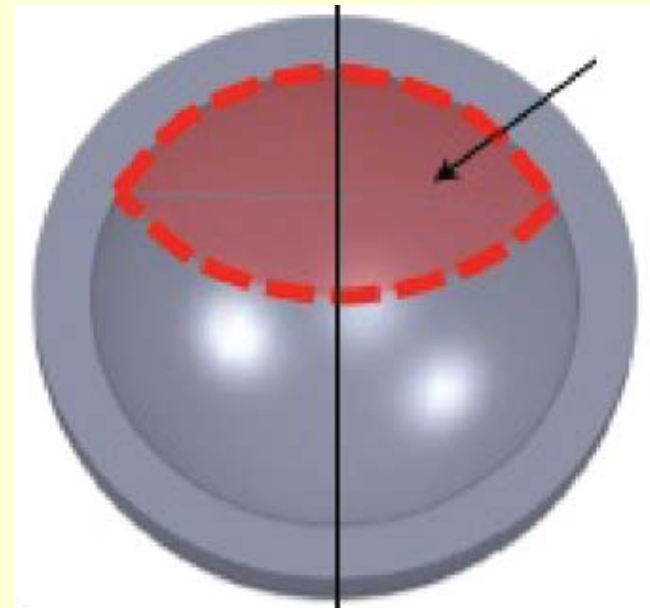
Edge Worn Cup

Edge Wear – The pattern of wear observed in acetabular cups in which the maximum depth of the wear scar occurs at the cup rim and progressively decreases along a path from the cup rim to the pole

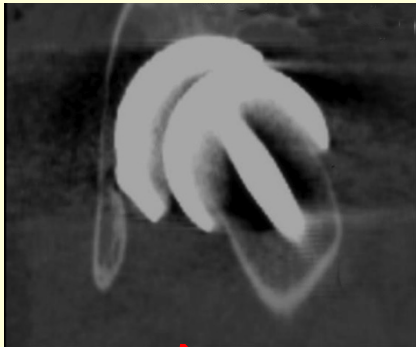
Impingement

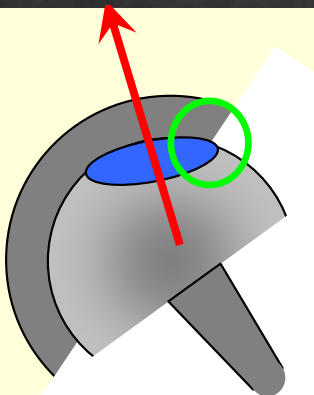
Micro Separation

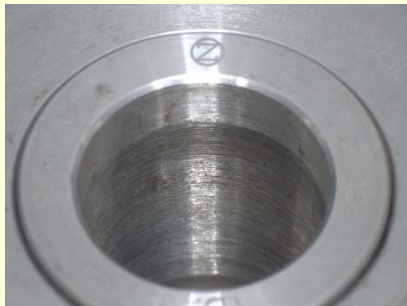
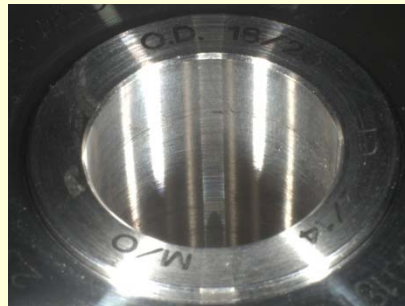
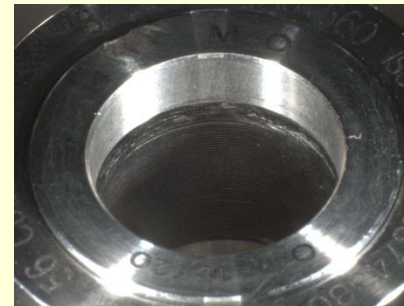
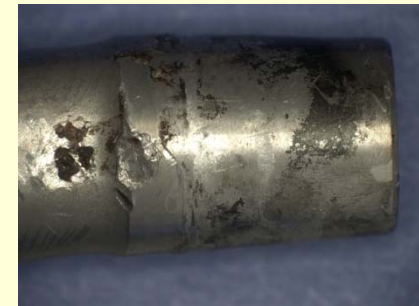
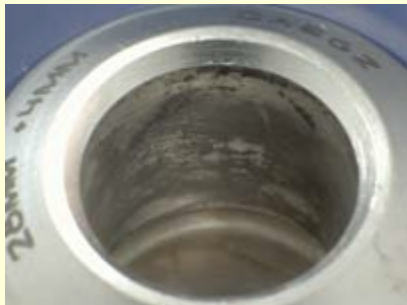
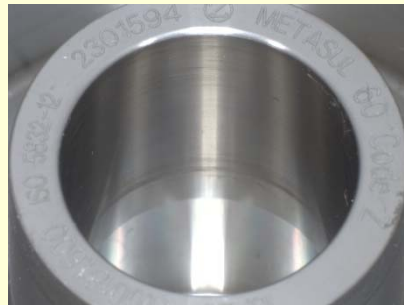
Goldberg observed “moderate to severe” taper corrosion in 42% of retrieved M-PE hips with dissimilar metals
